## **1.0 INTRODUCTION**

## Problem Areas by Watershed City of Creve Coeur, Missouri

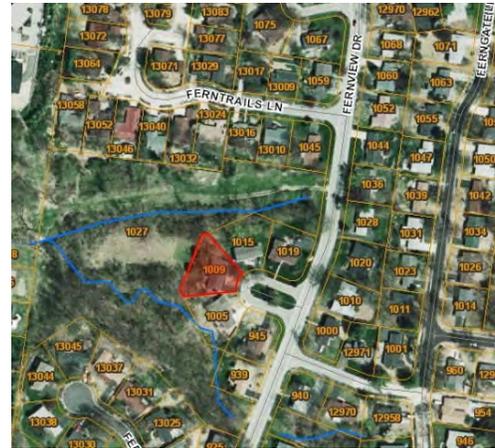
**PROBLEM DESCRIPTION:** Erosion at discharge of pipe at north section of backyard. Discharge of pipe was covered with yard waste and debris.

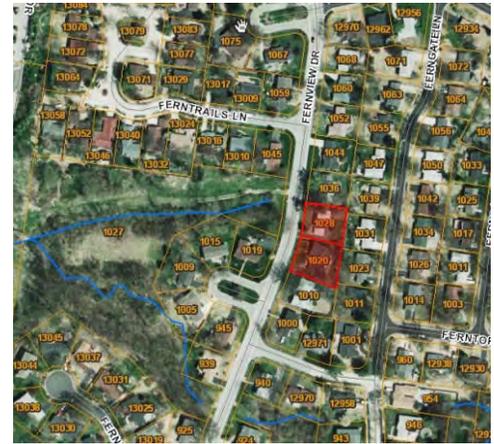
**PROBLEM DESCRIPTION:** Yard erosion observed in backyard of lot 1020 and 1028 Fernview due to runoff from homes behind on Ferngate Lane. Resident at lot 1028 has placed rocks along drainage path in an attempt to divert flow.

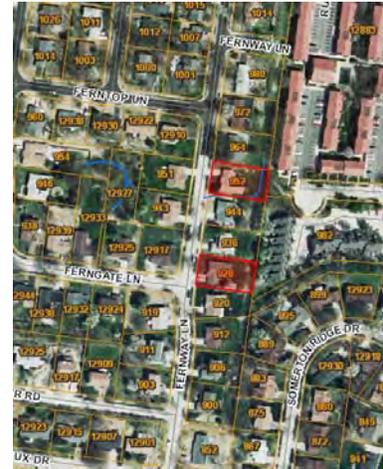
➤ **CC-3 - Fernway Lane #928**

**PROBLEM DESCRIPTION:** The original problem had two addresses affected. Per phone discussion with home owner at 952 Fernway Lane, yard has been regraded and an area inlet has been constructed to prevent ponding. Ponding still occurs at bottom of hillside of lot 928. Runoff is contributed from properties to the east. There is an area inlet located in backyard, but is not functioning properly because the sides of inlet have become backfilled. Home owner explained that water ponds in backyard and threatens patio.

**ALTERNATE SOLUTION:** Construct a double area inlet in place of existing inlet. Regrade yard as required.

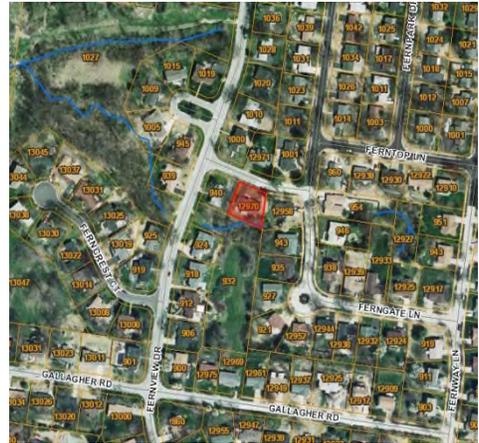
➤ **CC-4 - Ferntop Lane #12970**

**PROBLEM DESCRIPTION:** Creek erosion observed behind backyard. The most noticeable signs of erosion are along banks on south side. Creek banks are relatively shallow and are susceptible to flooding. There is fair amount of vegetation along creek. Pockets of standing water were present.

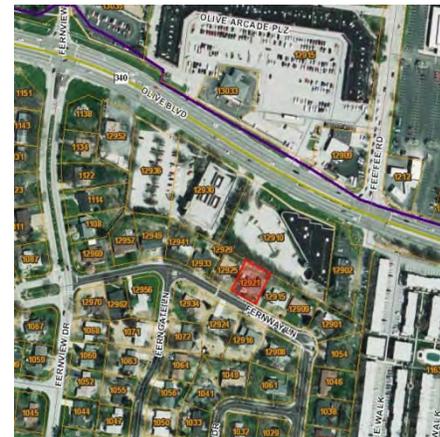
➤ **CC-5 - Fernway Lane #12921**

**PROBLEM DESCRIPTION:** Existing swale has been disturbed. Runoff from upstream is rotting away wood retaining wall. Backyard has potential areas to pond if runoff flows over or through wall. There is an area inlet as well as curb along parking lot behind home which appears to control runoff.

**PREFERRED SOLUTION:** Reconstruct swale to existing condition by regrading yard. Resident’s retaining wall will need to be removed.

**ALTERNATE SOLUTION:** Construct a new storm system to collect surface runoff and connect to existing system. The system would include 1 area inlet and 160’ of 12” RCP. Resident’s retaining wall will need to be removed.

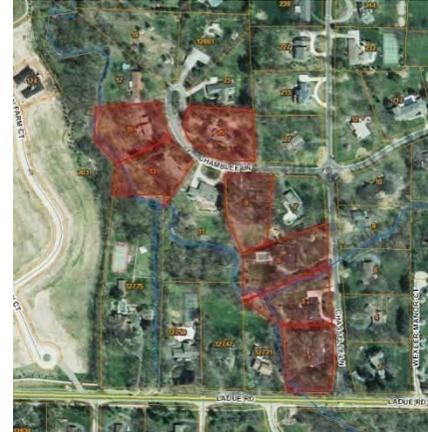
**PROBLEM DESCRIPTION:** Severe creek erosion observed. There were several fallen tree limbs and trunks. Utility poles are threatened. Creek has been rehabbed with gabion walls and rip rap at erosion locations. However, many areas along the creek remain affected by localized erosion. Backyards along creek have been disturbed by construction activity of a new sanitary sewer line so it was difficult to find evidence of flooding by field observation. Resident at 1 Chasselle has not experienced any issues within last few years, but no changes were made since the widespread flooding of August 1996. All homes along creek, with exception of lot 1, are distant from creek.

**PREFERRED SOLUTION (Erosion):** Place rip rap at locations along creek affected by erosion.

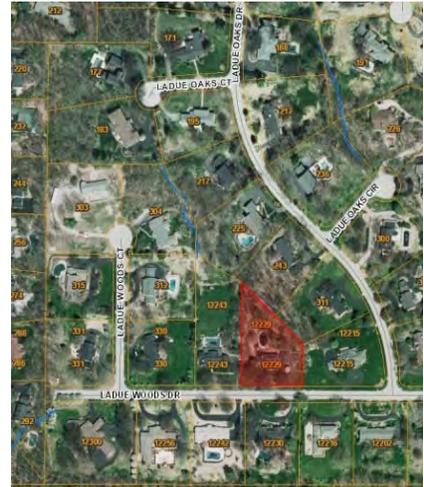
➤ **SC-2 - Ladue Woods Drive #12229**

**PROBLEM DESCRIPTION:** Runoff from homes on Ladue Oaks Drive causing yard erosion in backyard. Original swale has been disturbed by subsequent development. Silt fence and undersized drain has been installed. Home owner experiences no flooding into house, however driveway has been replaced to due runoff damage.

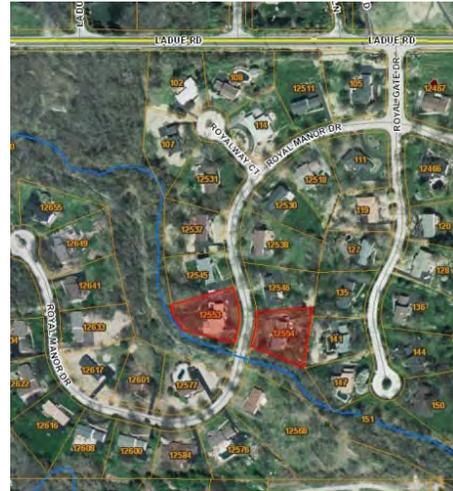
➤ **SC-3 - Royal Manor #12554**

**PROBLEM DESCRIPTION:** The original problem had two addresses affected. Per observation and discussion with home owner at 12553 Royal Manor Drive, creek has been rehabbed with rip rap and vegetation. Area is well maintained. Creek located along east side of lot 12554 has erosion at banks. Resident’s yard is being loss. Honeysuckle is prevalent along creek banks.

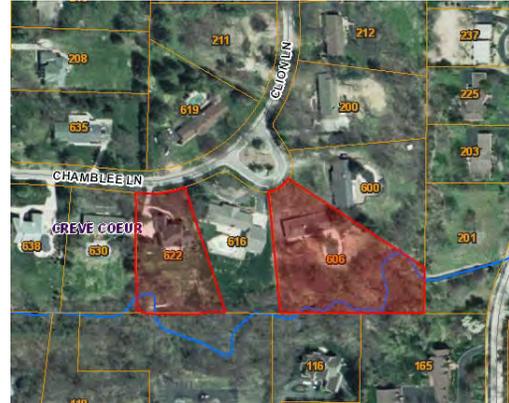
**PROBLEM DESCRIPTION:** Creek erosion observed in backyards of Chamblee Lane. Tree limbs and trunks have been exposed. Resident’s homes are greater than 100’ from creek.

\*These solutions are spot repairs. It is suggested that a watershed wide approach be taken to address the issues, however this is beyond the scope of work.

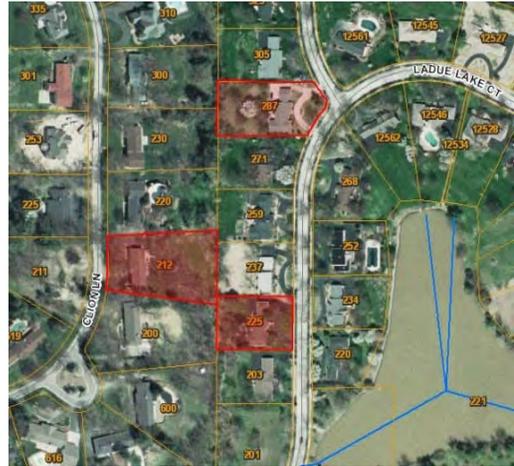
➤ **SC-7 - Clion Lane #212 & Ladue Lake Drive #225, 287**

**PROBLEM DESCRIPTION:** Gully erosion observed along grass swale in backyards of 212 Clion and 225, 287 Ladue Lake. Resident of 287 Ladue Lake explained that water runs like a creek through backyard and will pond in spots.

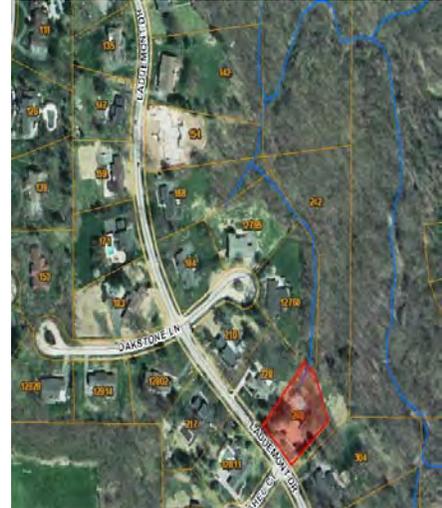
**PROBLEM DESCRIPTION:** Severe erosion at creek located in north section of backyard. A storm pipe discharges at this location, forming the start of creek. Although a part resident’s backyard is being eroded, there is no threat to home or pool.

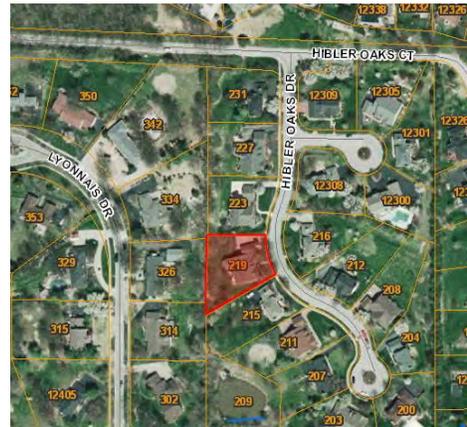
**PROBLEM DESCRIPTION:** Minor erosion observed in backyard. Tree roots have been exposed from erosion. Tributary area upstream has steep slopes. Yard has been recently seeded along drainage path.

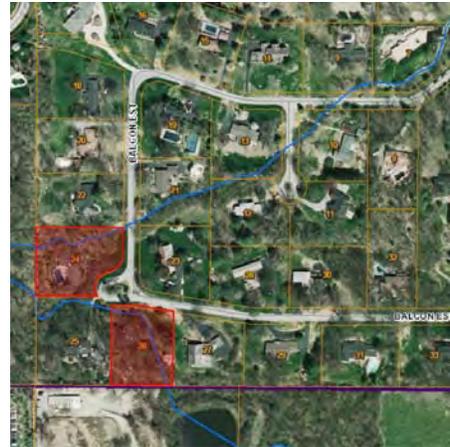
**PROBLEM DESCRIPTION:** 24 Balcon Estates- There is severe creek erosion at banks. Erosion is threatening yard, but not house. There is a gabion wall downstream of bridge which appears to have been washed away. There is no erosion protection available at banks.

26 Balcon Estates- Gabion wall has been installed along creek banks. There is an upstream section of creek with no gabion walls. This section has heavy erosion and trees uprooted. In backyard, runoff collects from hillside and ponding occurs. Resident has built temporary ditch to collect this runoff and convey to creek. Resident explained that creek reaches high water levels causing flooding of bridge and property. History and more info on issues are available from home owner.

**ALTERNATE SOLUTION:** It is recommended to conduct a watershed analysis to better understand flow rates and volumes passing through creek.

\*These solutions are spot repairs and do not resolve creek flooding. It is suggested that a watershed wide approach be taken to address the issues, however this is beyond the scope of work.

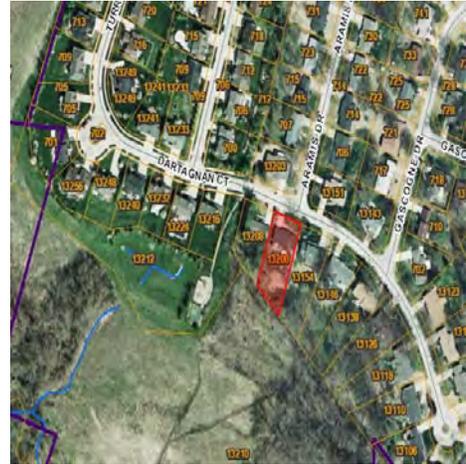
➤ **SC-11 - Dartagnan Court #13200**

**PROBLEM DESCRIPTION:** Per phone discussion with home owner, there is erosion at end of discharge pipe which is located on hillside. Dirt has been washed away from under pipe. Issue has been reported to MSD, but not the City of Creve Coeur

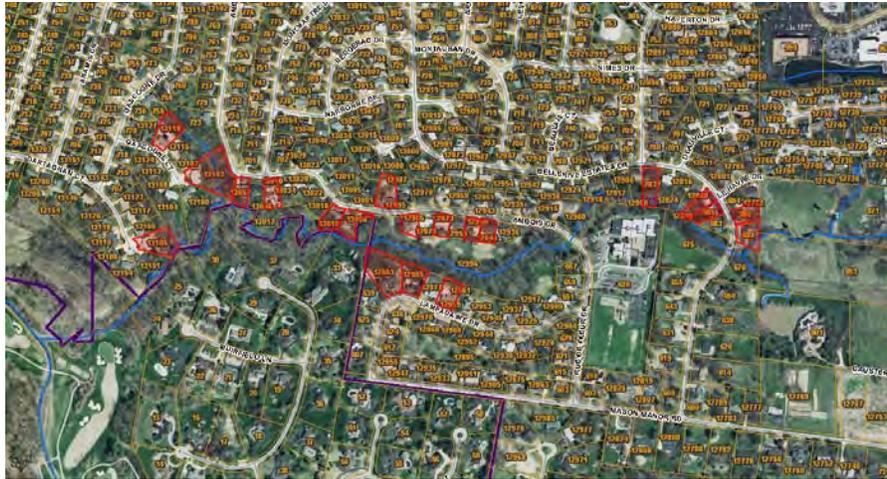
➤ **FC-1 - Fernridge Creek between Dartagnan Court and Bellerive Estates Drive**

**PROBLEM DESCRIPTION:** Several properties are affected by flooding and erosion along Fernridge Creek. Many homes are located in a 100-year flood plain. Mild to severe erosion occurs along creek banks.

A storm event that occurred in that location on August 23<sup>rd</sup>, 1996 flooded approximately 34 homes. The actual flooding was caused by a combination of circumstances. Following the entry of surface floodwater through basement windows and flooding basements (many of which were finished as recreation rooms etc.) the water in those basements with depths of up to 6’ entered floor drains and laundry drains, pressurizing the sanitary trunk and emerging into basements of homes that did not have openings below the floodwater elevation. In addition to the water entering the trunk sewer in that way, much apparently infiltrated through cracks or bad joints in the aging trunk sewer. In the years subsequent to the flood, MSD replaced the trunk sewer; that has likely reduced the chances of infiltration but there remains the issue of surface flooding. The “footprint” of the flood very closely followed the floodplain that is depicted on the effective Flood Insurance Rate Map (FIRM) for the area.

The solutions examined in the MSD Stormwater System Master Improvement Plan (SSMIP) for Creve Coeur Watershed included methods to prevent flooding by increasing stream capacity and to construct a major detention basin at the northwest quadrant of Mason Road and Mason Manor Drive. The costs of the proposed solutions were respectively estimated at that time (ca 1998) as \$4,611,000 and \$1,614,000. Additional studies as found in Appendix C were performed for the City of Creve Coeur following the SSMIP, but in all cases the remedies are extremely expensive.

*Floodproofing of the individual homes is doable and could prevent a repeat of the damage incurred in 1996. The issue that remains is determination of what, if any, degree of participation there would be from the city. There is a logical reluctance to spend public funds on private property. However if the city does at times pay for channel and bank protection with the acknowledgment that such projects serve primarily to protect homes from flooding, then it maybe be to the city's fiscal advantage to participate in individual floodproofing at far less cost than expensive channel improvements. Unlike channel and bank improvements that require easements and 100% participation by property owners, individual owners could opt-in or –out of such a program.*

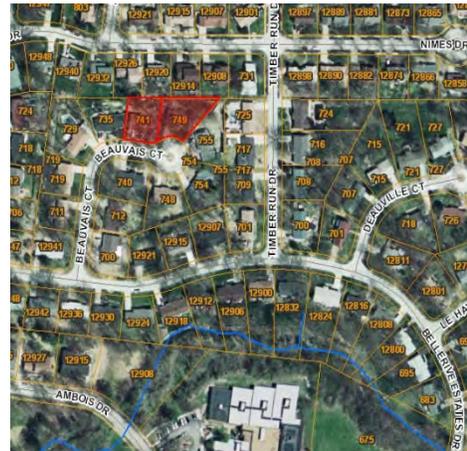
➤ **FC-2 - Beauvais Court #741, 749**

**PROBLEM DESCRIPTION:** Original problem had five addresses affected. Per discussion and observation, Lot 735 has a new swale and area inlet constructed to collect runoff. Lot 712 and 729 have no current stormwater issue per discussion with home owners. Runoff from Nimes Drive is flooding and eroding backyards of 741 and 749. Lot 741 has greatest concern due to flooding endangering house.

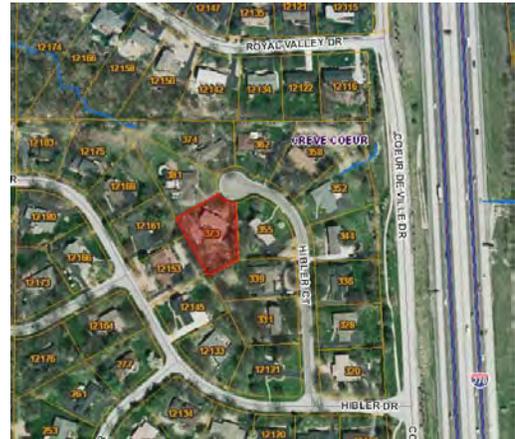
**PROBLEM DESCRIPTION:** Concrete flume does not properly control runoff from neighboring subdivision. Flume was clogged with leaves. Home owner has placed rocks on side of flume as a barrier when water exceeds flume. Filter fabric placed in corner of yard to prevent further washout of yard.

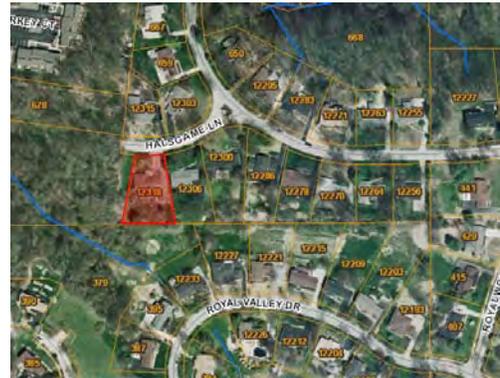
**PROBLEM DESCRIPTION:** Minimal erosion observed along backyard fence line. Site was mostly covered in leaves and debris. Most noticeable yard erosion was evident in southwest corner of yard. Erosion does not threaten house or any structure.

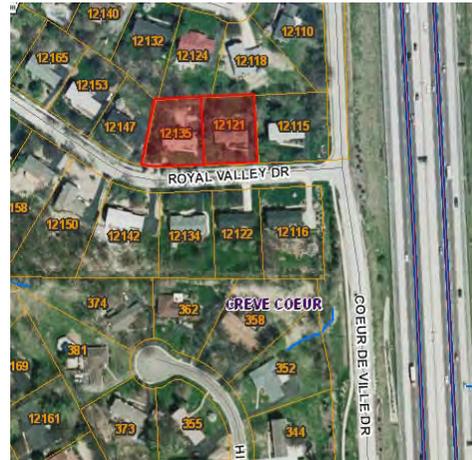
➤ **FC-6 - Royal Valley Drive #12121, 12135**

**PROBLEM DESCRIPTION:** Rill erosion observed in backyard of 12121 Royal Valley. Yard has eroded most near fence line on west side of property. Surrounding tributary area appears relatively flat. Resident has placed railroad ties to mitigate erosion. Backyard of lot 12135 has also been affected by runoff causing yard damage.

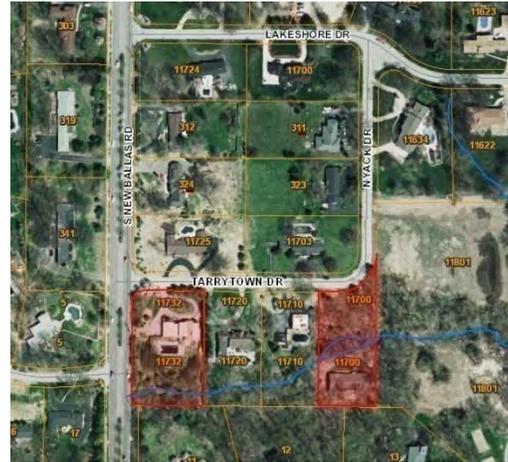
➤ **DC-1 - Tarrytown Drive #11732, 11700**

**PROBLEM DESCRIPTION:** Original problem had three addresses affected. Per discussion and observation at 11600 Lakeshore Drive, no stormwater issue present. Evidence of severe creek erosion behind backyard fence of 11732 Tarrytown. Tree branches and other yard waste have been placed on the banks to prevent further creek erosion. Flooding appears to be main concern at 11700 Tarrytown. Resident explained that creek floods upstream and downstream of culvert. Water ponds causing a potential health issue. Resident has planted vegetation in an attempt to mitigate issue.

**ALTERNATE SOLUTION:** It is recommended to conduct a watershed analysis to better understand flow rates and volumes passing through creek.

\*These solutions are spot repairs. It is suggested that a watershed wide approach be taken to address the issues, however this is beyond the scope of work.

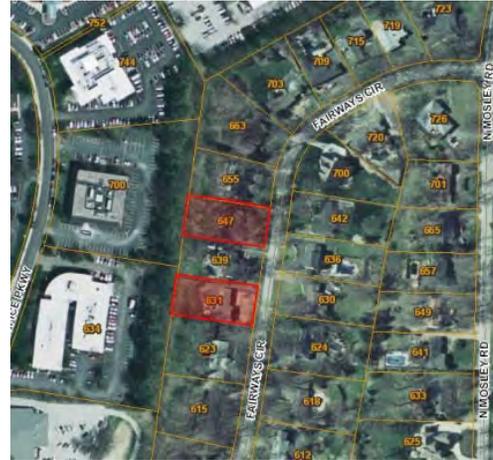
➤ **DC-2 - Fairways Circle #631, 647**

**PROBLEM DESCRIPTION:** The original problem had three addresses affected. Per discussion and observation of 639 Fairways Circle, a French drain has been installed in backyard to mitigate runoff. Issues still present at 631 and 647 Fairways Circle. Runoff from hillside behind commercial properties drains to backyards where it ponds and causes yard erosion. Hillside has steep slope. Embankment at top of hill controls runoff from parking lot. Home owner at lot 647 explained that backyard runs full of water during a storm event, but has not experienced house flooding. Home owner of lot 631 has placed rock along drainage path to mitigate erosion damage.

**ALTERNATE SOLUTION:** Construct an area inlet in the backyard of both lot 631 and 647 that are not interconnected. Each area inlet would be connected to the existing storm sewer located along Fairways Circle. System would include 2 area inlets, 260' of 12" RCP, and possible addition of a new curb inlet.

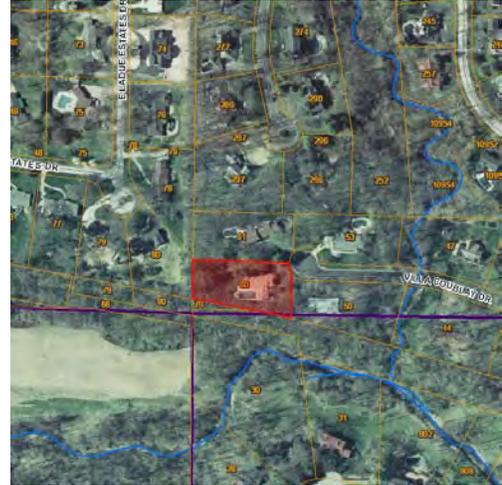
**PROBLEM DESCRIPTION:** Significant creek erosion observed along old railroad right-of-way. Backyard surface elevation of lot 60 is approximately 25' above the creek.

\*These solutions are spot repairs. It is suggested that a watershed wide approach be taken to address the issues, however this is beyond the scope of work.

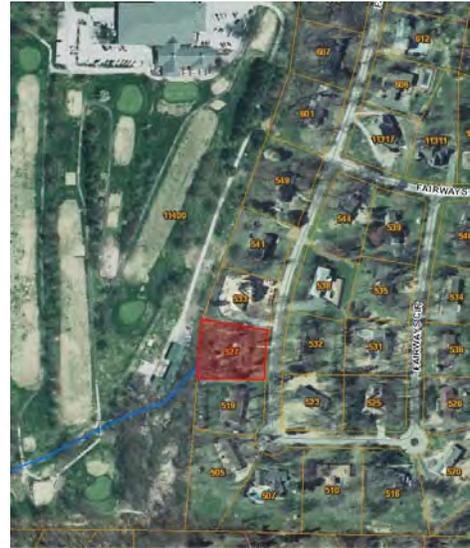
➤ **DC-4 - Fairways Circle #527**

**PROBLEM DESCRIPTION:** Erosion has occurred at top of bank from runoff from backyard. The eroded surface has been filled in with yard clippings. Creek along golf course discharges along side of headwall causing erosion. Stagnant water is present at headwall discharge. No evidence of damage to home owner’s yard.

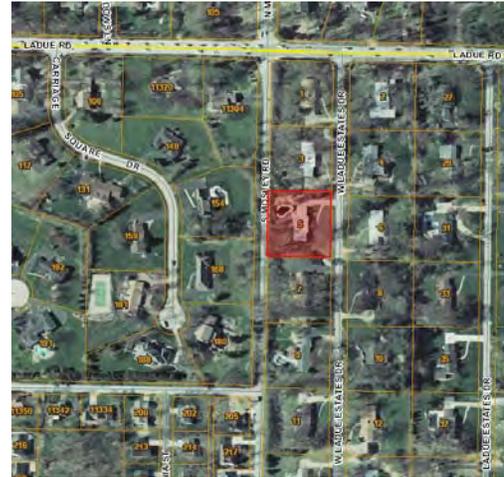
**PROBLEM DESCRIPTION:** Minor erosion observed along backyard near landscaping. Landscaping does not appear damaged. Home owner has placed yard waste in backyard to possibly alleviate problem. Honeysuckle vegetation is present.

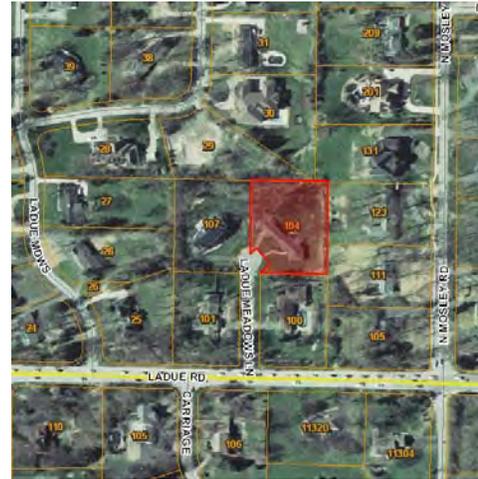
**PROBLEM DESCRIPTION:** Rill erosion observed along west side of property line contributed from runoff of Ladue Meadows. Yard damage observed in backyard, but unable to determine if caused from ponding water. It may be a result from area inlets in backyards of Mosley not being capable of handling flow. Base of MSD inlet at southwest corner of property has eroded.

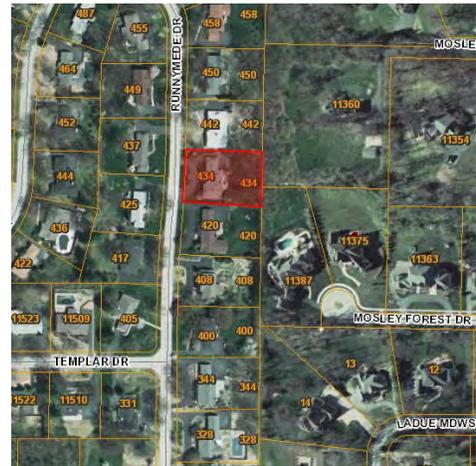
**PROBLEM DESCRIPTION:** Runoff from neighboring subdivision appears to be flowing down south side of property causing minor rill erosion and marshy ground conditions. Home owner has installed a drain to mitigate issue. Ponding may also be possible on north side of property near driveway, although not evident during site visit.

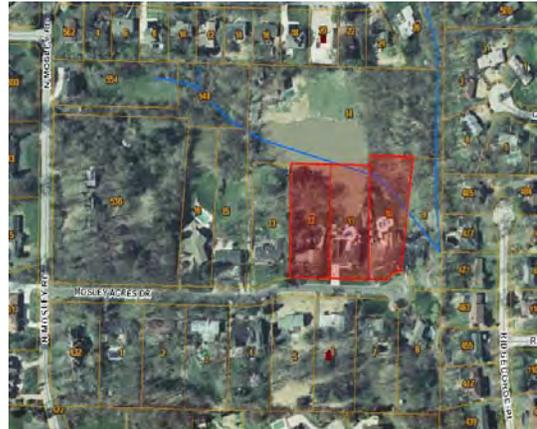
➤ **WC-1 - Mosely Acres Drive #10, 11, 12**

**PROBLEM DESCRIPTION:** Overtopping of dam causing flooding at lot 10. Spillway (overflow) of dam is covered with debris and vegetation. Earth dam on east side of Mosley Lake covered in vegetation. Shore erosion along south side of lake.

**ALTERNATE SOLUTION:** There is no other feasible alternative.

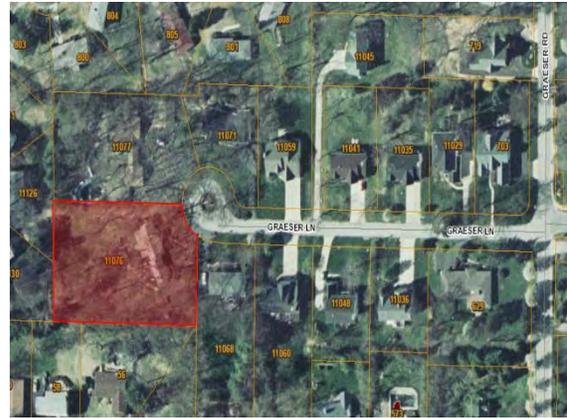
**PROBLEM DESCRIPTION:** Flooding occurs in front yard, despite the rip rap channel that exists, intended to collect flow. Water has entered through home's foundation according to resident. Resident explained that newly remodeled homes on Graeser Lane have created additional runoff. Resident has installed drain in sidewalk as well as French drain around front of house.

**PREFERRED SOLUTION:** Construct a new curb along resident's property to contain street runoff. Portion of street may need to be replaced to allow runoff to discharge through rip rap channel.

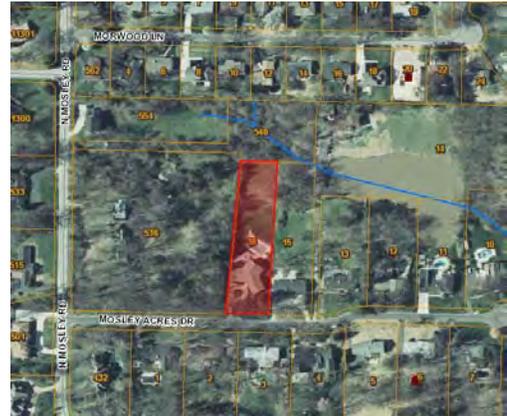
➤ **WC-3 - Mosley Acres #16**

**PROBLEM DESCRIPTION:** Mosley Acres has been resurfaced (asphalted) causing the curb and gutter not to function properly. Minor erosion damage observed 1'-2' next to street curb. Resident has seeded area. Other properties along Mosley Acres have similar problem.

**PREFERRED SOLUTION:** Remove and replace approximately 400' of curb and gutter. Seed resident's yards that have been damaged by erosion.

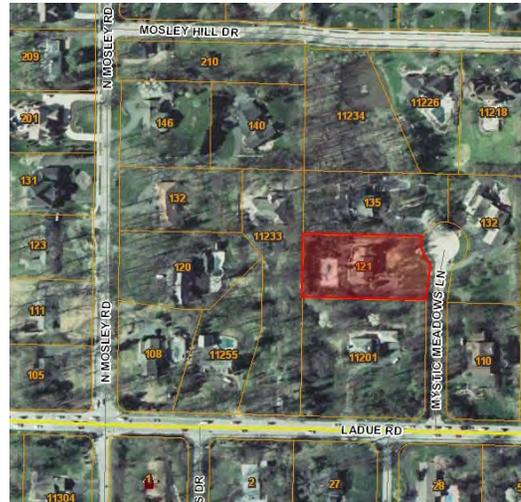
**PROBLEM DESCRIPTION:** Erosion observed along south and north property line (with most severe along south side). Evidence of ponding on south side. Home owner has constructed a berm to control water. Gully erosion at upstream side of property. Home owner has built a wall along driveway to prevent water from flowing onto driveway. A drain has also been installed in attempt to collect a portion of runoff, however, it is undersized. Priority shall be given to the south side of property.

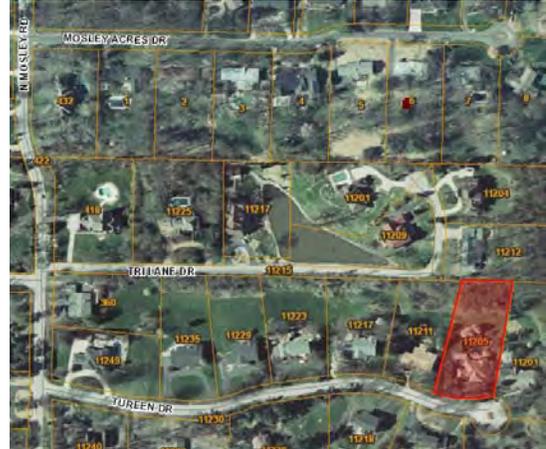
**PROBLEM DESCRIPTION:** Backyard has slight erosion. The site had been disturbed by recent construction of a new retaining wall and was difficult to assess erosion conditions in backyard. Erosion observed at base of MSD area inlet. Resident explained that erosion in backyard has been worse in years past. Resident also explained that a sink hole is present in backyard along berm. Additional photos and history of the issues are available from home owner if needed.

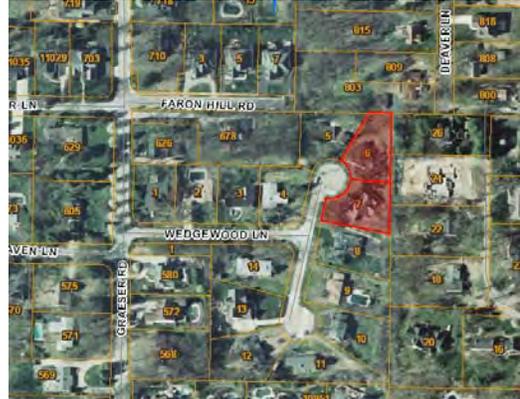
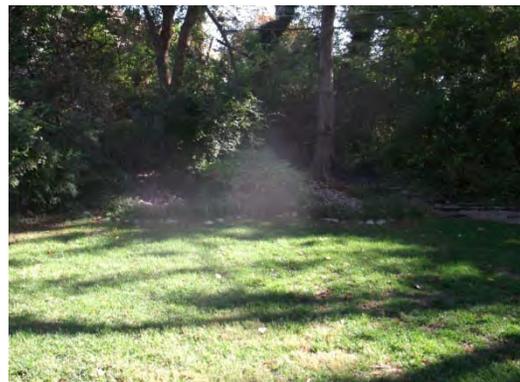
➤ **WC-6 - Wedgewood Lane #6, 7**

**PROBLEM DESCRIPTION:** Per discussion with home owner of 6 Wedgewood, runoff from new homes on Deaver and Colonial Hills Parkway is adversely flooding backyard of 6 and 7 Wedgewood after every rain event. Water ponds for several days before draining. Resident explained that water has never entered home, but could if his French drain system ever clogged. Resident also explained that slight erosion occurs on the hillside of backyard.

**ALTERNATE SOLUTION:** Construct a grass swale with turf reinforcement mat and route to street curb of Wedgewood.

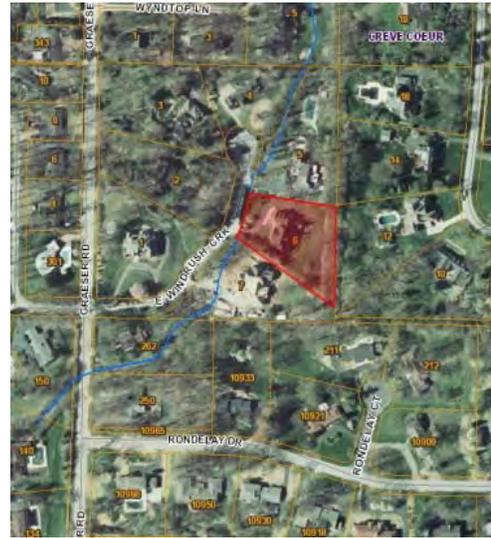
**PROBLEM DESCRIPTION:** Severe channel erosion observed in front yard. Resident explained that second pipe culvert was added after new home construction was completed upstream of creek. To relieve street flooding, new curb inlets have been constructed. This contributed additional flow to channel. Resident explained that creek has reached water levels up to top of bank. Erosion was visible on north side of headwall.

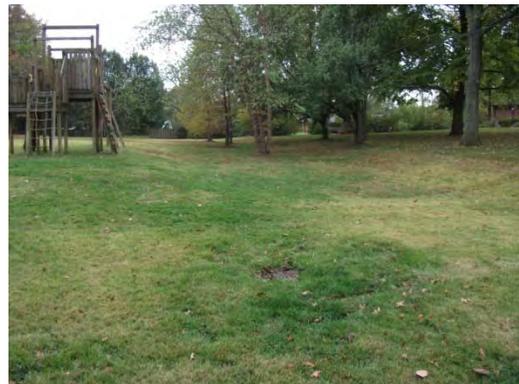
➤ **WC-8 - Ladue Estates Drive #71, 73**

**PROBLEM DESCRIPTION:** Backyard between lot 71 and 73 was soggy during site visit. No erosion was observed. Resident of lot 71 explained that water runs through backyards and certain areas pond due to insufficient slope of land. At times, runoff diverts from backyard path and drains between the houses. Resident of lot 73 placed rock landscaping around trees as a possible measure to protect trees from flooding.

**ALTERNATE SOLUTION:** Construct a storm sewer system to collect runoff and route to existing storm inlet. The system would include 2 area inlets and 300' of 12" RCP.

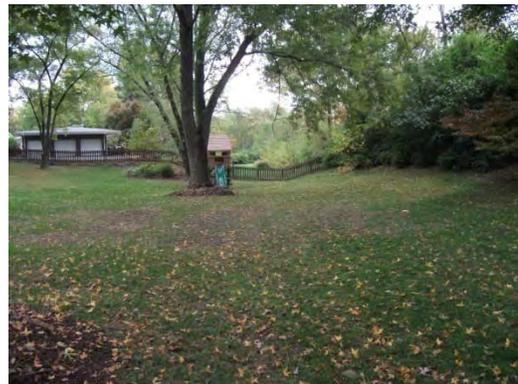
➤ **MS-1 - Spoede Acres Street #2**

**PROBLEM DESCRIPTION:** Yard on west side of lot 2 has been damaged from runoff. Backyard has been eroded from runoff from adjacent yards. An area inlet exists in backyard, but runoff does not drain properly according to resident. Backyard of lot 1 has same issue in which runoff drains into yard.

**ALTERNATE SOLUTION:** Create a natural stream/pool environment in place of existing storm system and swale. However, this alternative was deemed uneconomical.

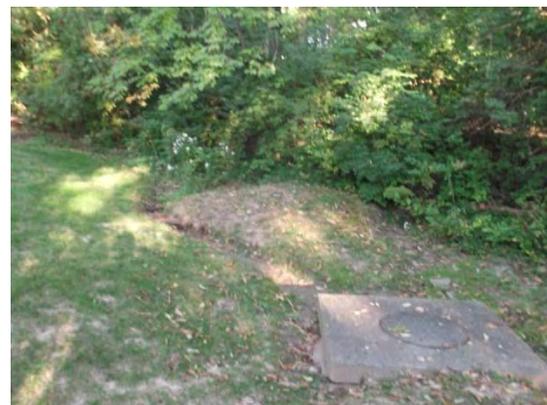
➤ **MS-9 - Rondelay Drive #10835**

**PROBLEM DESCRIPTION:** Channel erosion observed upstream of MSD inlet. Home owner explained that runoff from adjacent properties has increased over the years causing erosion damage to yard. Home owner has installed two drains to alleviate flooding from street. Street has been overlaid with asphalt causing runoff to spill over street curb.

**ALTERNATE SOLUTION:** Construct 2 area inlets upstream of existing MSD inlet to intercept runoff. Connect the 2 new inlets to the existing storm sewer with 200' of 12" RCP.

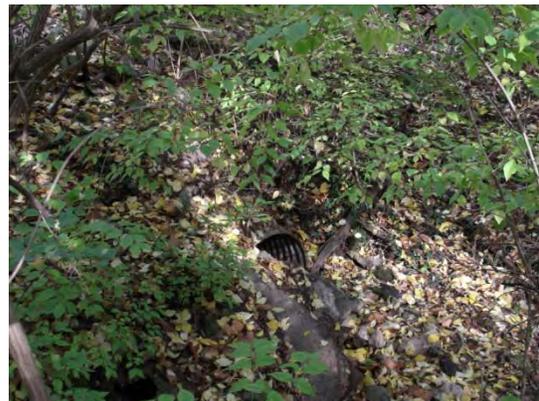
➤ **PC-1 - Tealwood North Drive #47**

**PROBLEM DESCRIPTION:** Slight erosion at culvert headwall and outlet. Timber bracing on upstream side. Resident says it was put there to help shore-up the headwall. According to resident, there are no flooding problems. Washout on right descending bank (looking downstream) approximately 60' upstream of culvert. Banks generally well-vegetated except for washout area.

**PREFERRED SOLUTION:** Replace existing culvert.

**ALTERNATE SOLUTION:** Construct heavy revetment 20' upstream and downstream of culvert to prevent erosion. This solution helps with erosion, but does not improve the structural integrity of the culvert.
